Puma Bitumen Case Study

OLEXOBIT® HSS Sprayed Seal

Millmerran Inglewood Road, QLD

Date: January 2009

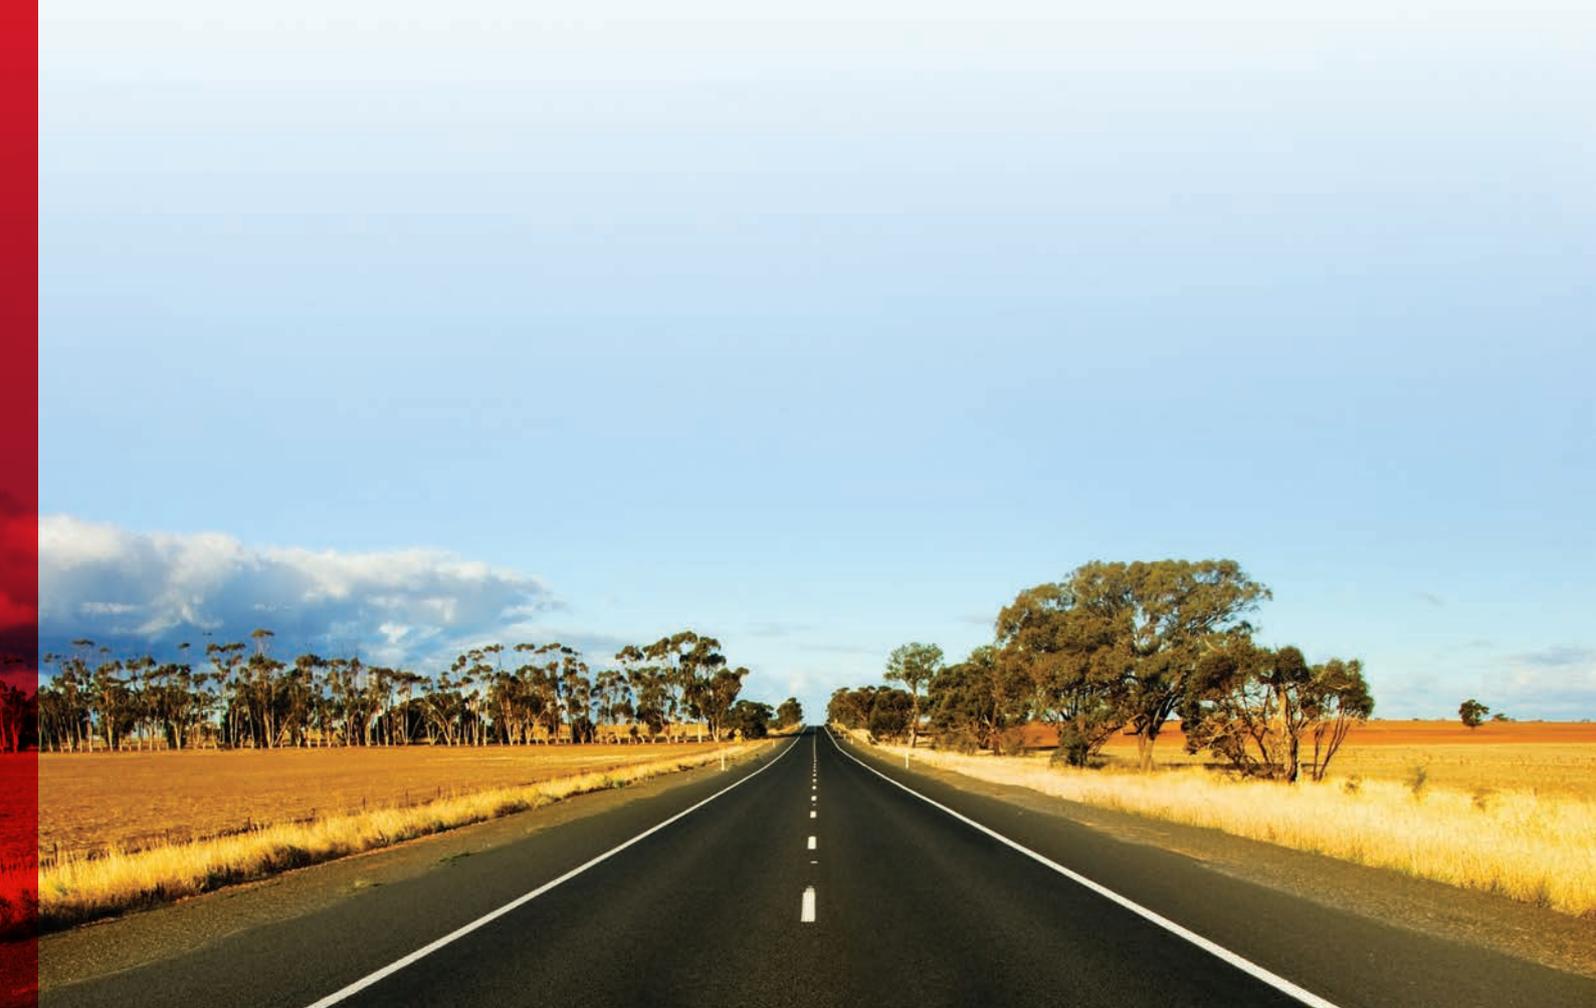
The OLEXOBIT® HSS Millmerran project involved the placement of the final seal on a two lane section of the Millmerran Inglewood Road, 15km south of Millmerran in Queensland. The pavement was reconstructed and widened in 2006 and the planned seal was the final seal for the construction project. This is required to provide a durable and waterproof seal and to retain good texture in the long term.

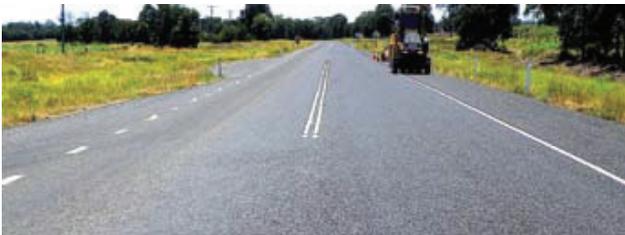
The purpose of the pavement upgrade was to establish the road as a through link for road trains. A normal seal in this situation would be designed for the low traffic count, but might be compromised by the damaging effects of the heavy vehicles, potentially suffering from loss of texture due to flushing, or from loss of cover aggregate.

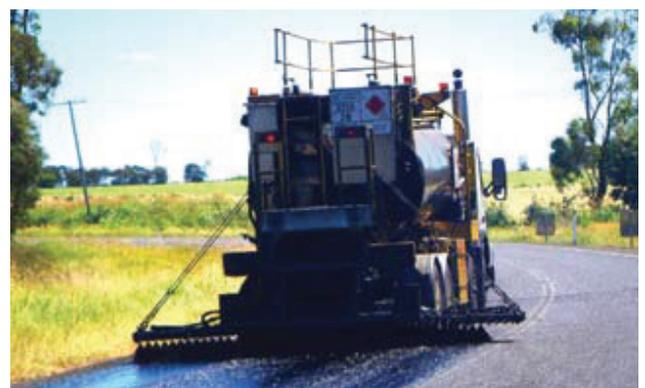
RoadTek applied the binder using their dual bar transverse variable sprayer. A higher binder application rate of 2.0 L/m² was applied between and outside the wheelpaths – and a lower rate of 1.7 L/m² was applied in the wheel paths.

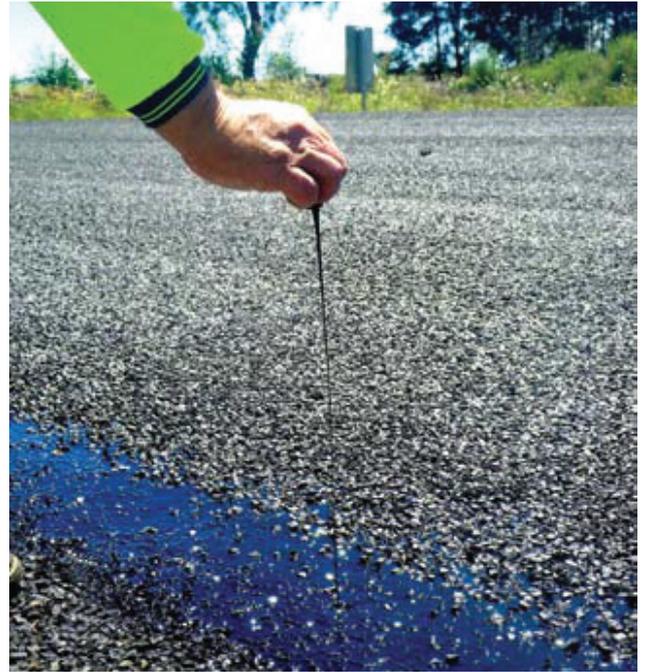
Inspection of the seal at 3 months showed it to be performing very well with excellent binding of the cover aggregate. A stone was removed to show that the binder was lively and elastic, as demonstrated by stringing of the binder. Inspection of an adjacent section of the seal constructed using M500/170 multigrade bitumen showed less binder strength and no stringing.
